PROTECTED TREE REPORT
for
the Meadows at Bailey Canyon Project
City of Sierra Madre, California

JANUARY 2022

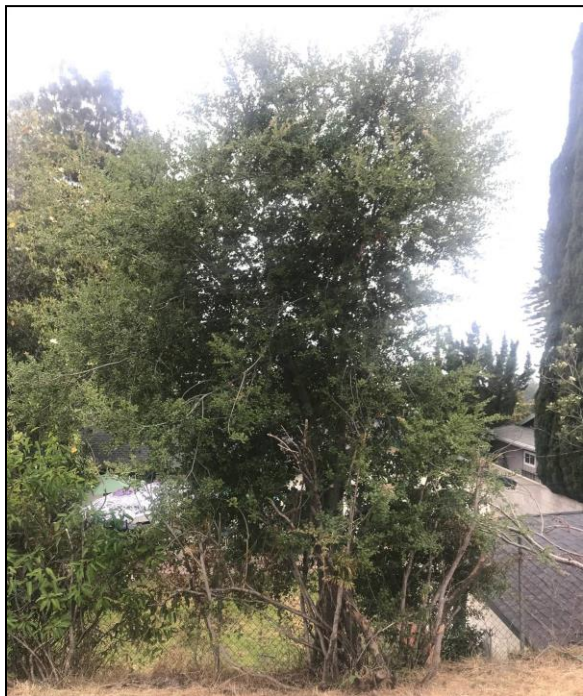
Photo 5. Photograph of protected coast live oak tree #1.

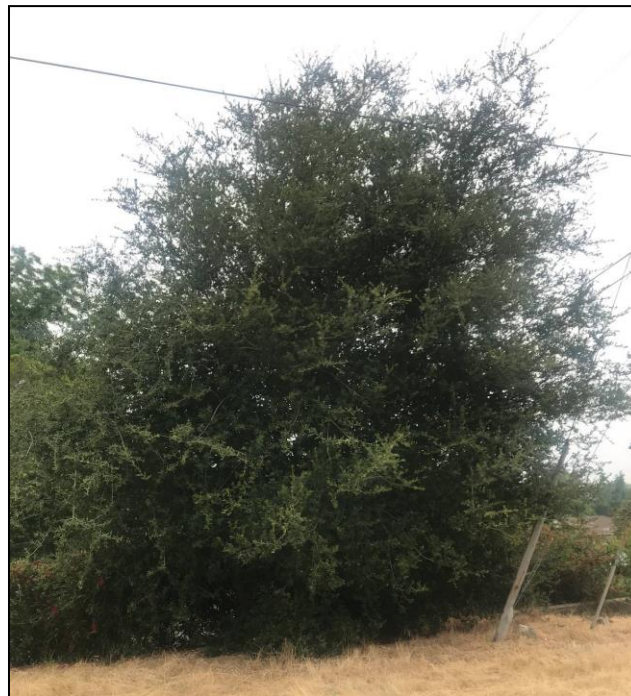
Photo 6. Photograph of protected coast live oak tree #2.

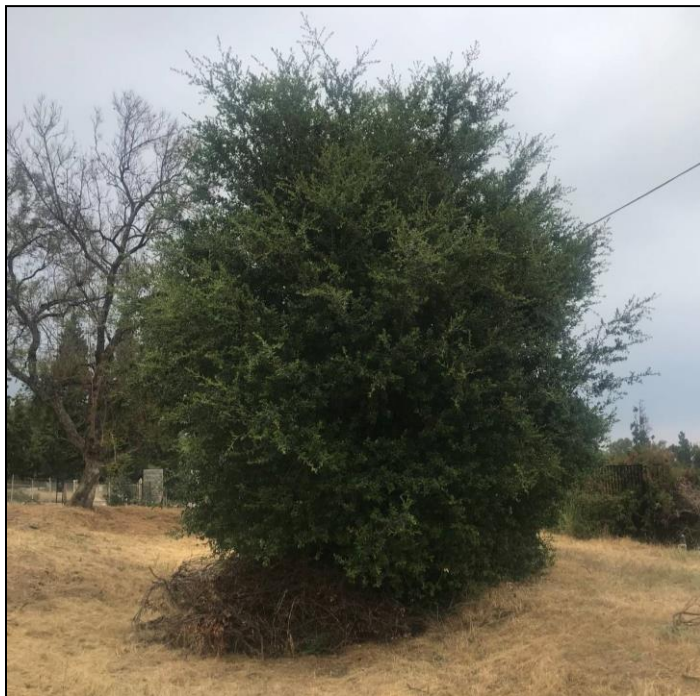
Photo 7. Photograph of protected coast live oak tree #3.

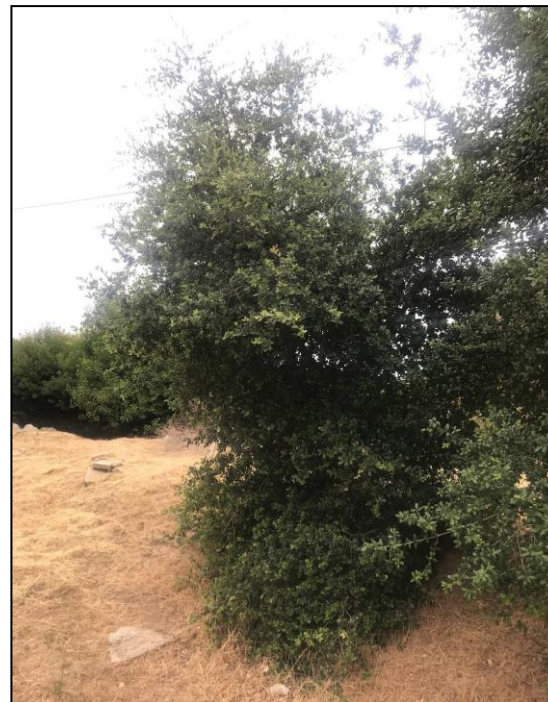
Photo 8. Photograph of protected coast live oak tree #4.

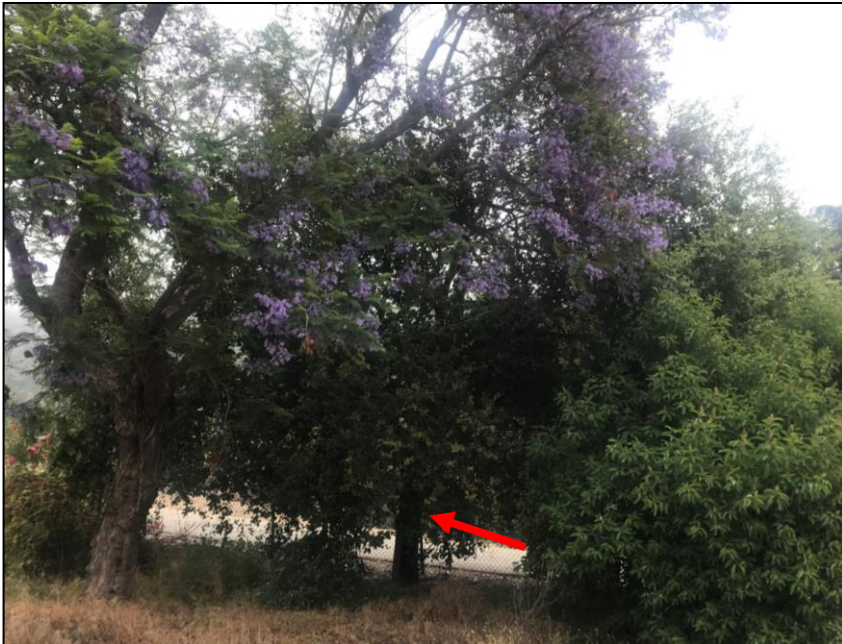
Photo 9. Photograph of protected coast live oak tree #15.

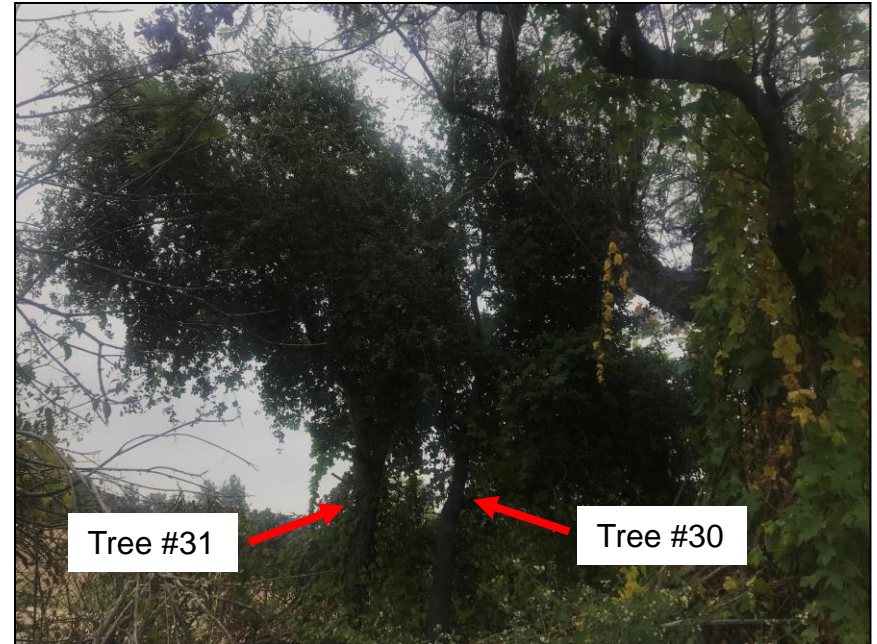
Photo 10. Photograph of protected coast live oak trees #30 and #31.

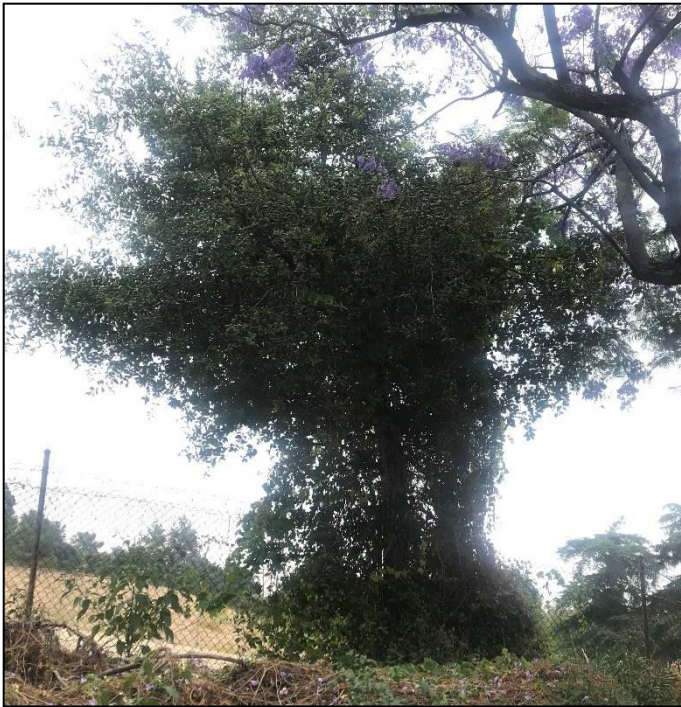
Photo 11. Photograph of protected coast live oak tree #33.

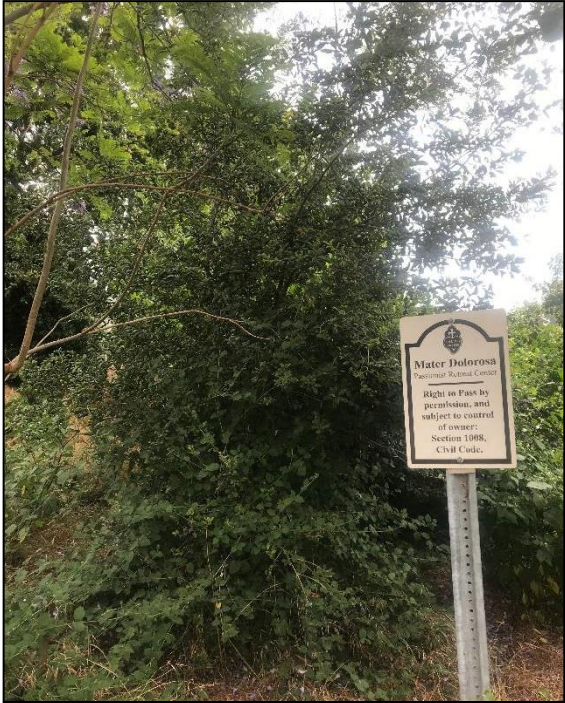
Photo 12. Photograph of protected coast live oak tree #43.

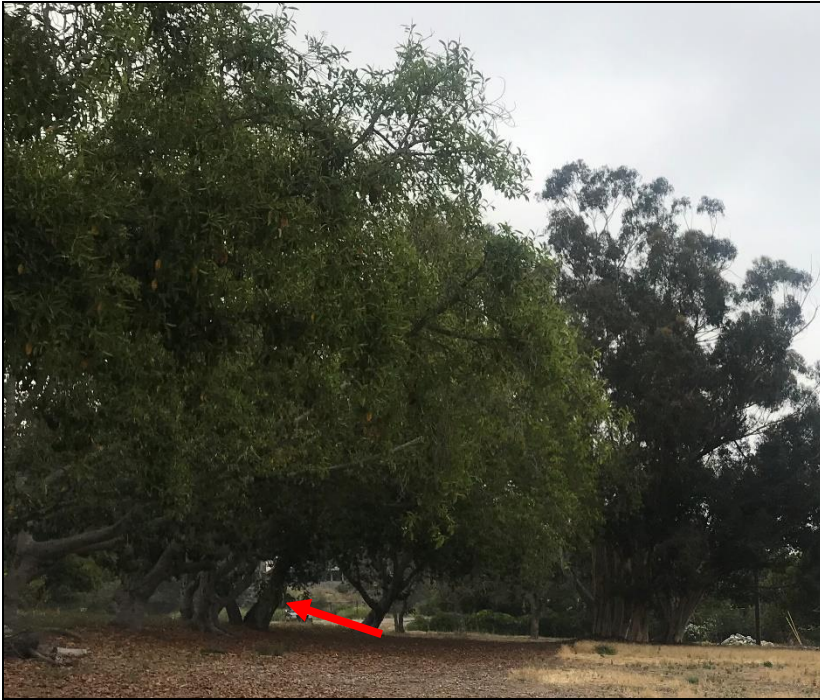
Photo 13. Representative photograph of protected coast live oak tree #61.

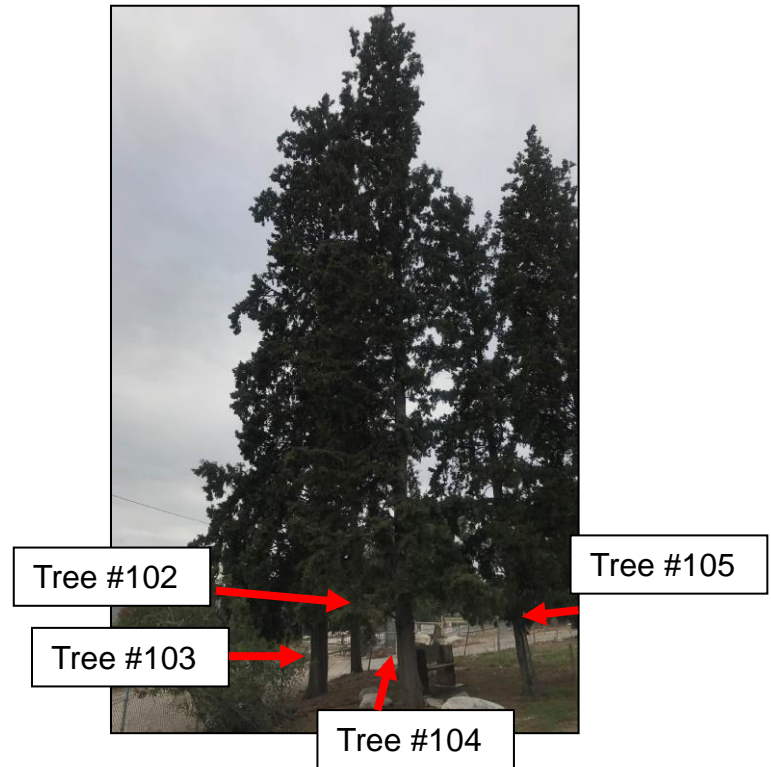
Photo 14. Representative photograph of protected trees nos. 102, 103, 104, 105.

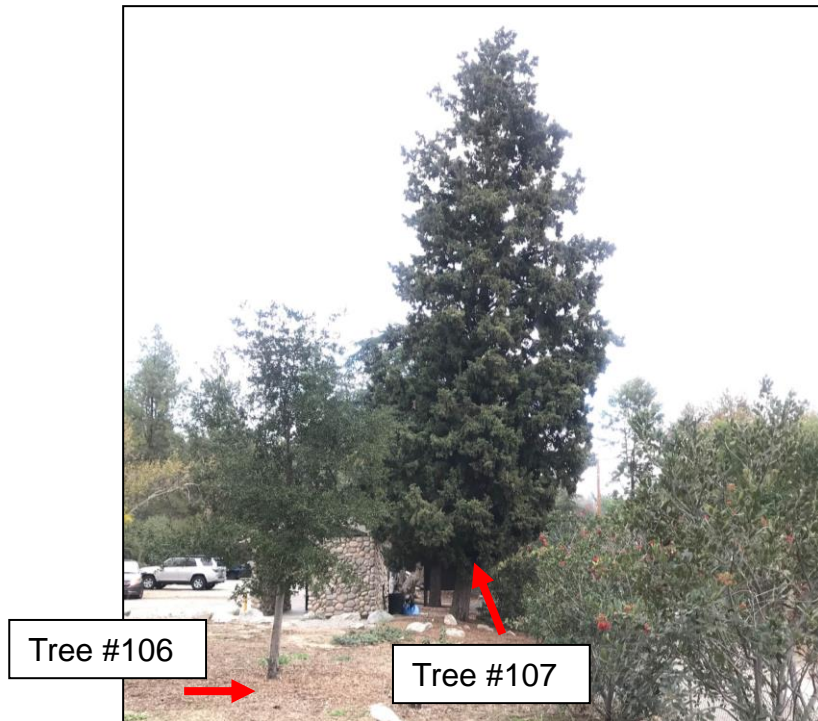
Photo 15. Representative photograph of protected tree nos. 106 and 107.

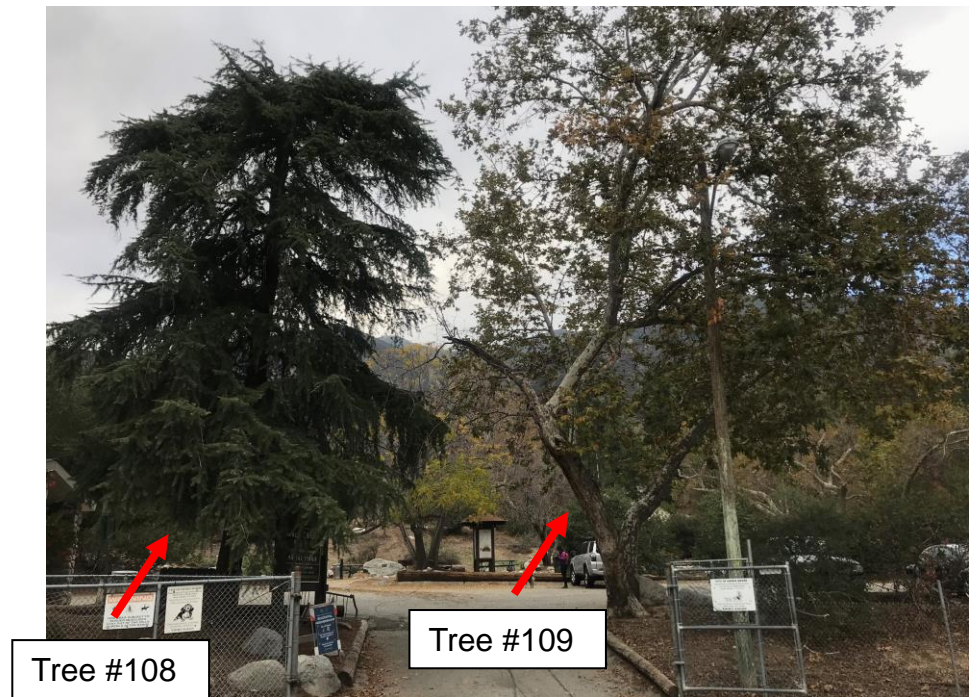
Photo 16. Representative photograph of protected trees nos. 108 and 109.

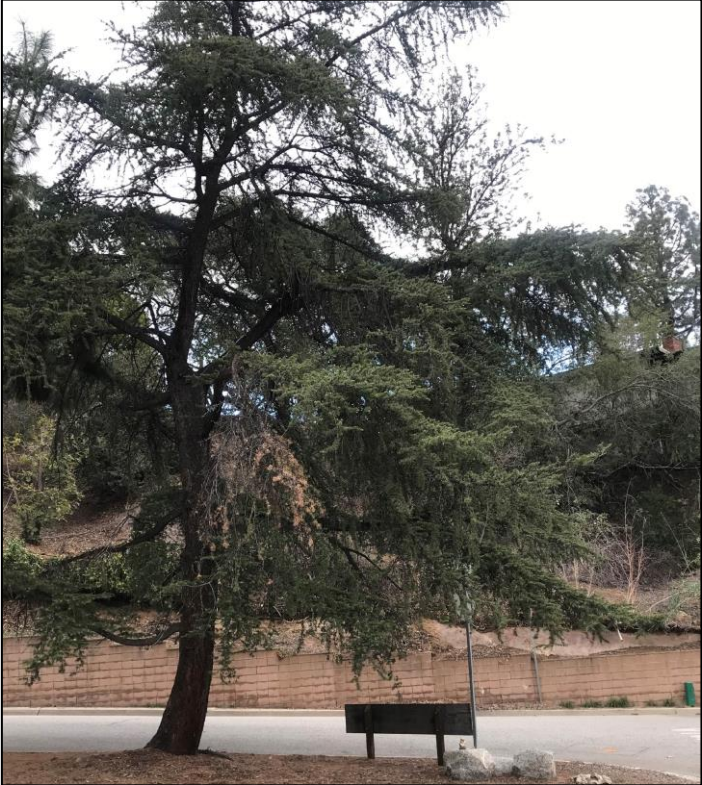
Photo 18. Representative photograph of protected tree no. 117.
